INSPECTION REPORT  
264 Springs East Rd.  
Timberlake NC 28092-9550

INSPECTED BY  
Adam Cole License  
#2169  
Coles Inspection  
Services  
#2169

INSPECTION DATE  
📅 10/30/2025  
🕒 09:30 AM

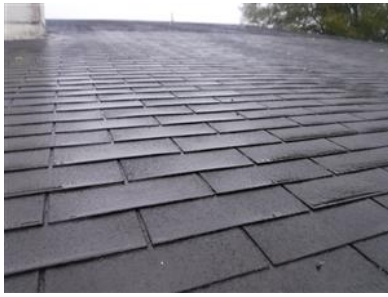
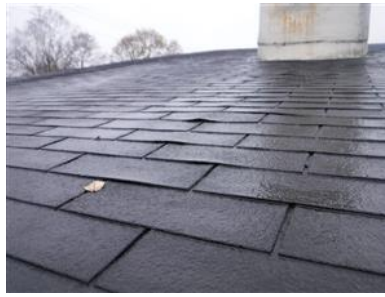
The roof shingles are curled and brittle and are pitted in areas. Areas have also been heavily caulked or

sealed. The life remaining is unknown. Recommend further evaluation by a licensed roofing contractor.

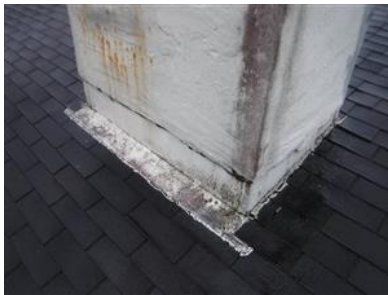
1.1 Item 1 (Picture)

Flashing around chimney has been caulked. This area may leak (or could be leaking). Water intrusion into the home can lead to costly repairs and/or undesirable living conditions. Recommend monitoring for leaks and repair as needed by qualified contractor. Periodic inspection/maintenance of any caulked flashing is also recommended.

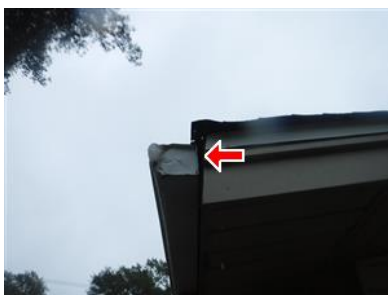
1.2 Item 1 (Picture)

(1) The gutter along the right side of home has pulled away from the fascia board and is not operating properly. Water intrusion in through the foundation may occur if not corrected (or is occurring). Water infiltrating the home may cause damage to the structure and/or cause fungal growth. Repairs are needed. Recommend a qualified professional evaluate further and repair.

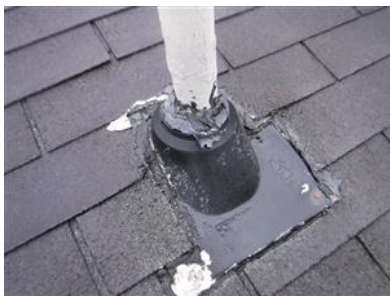
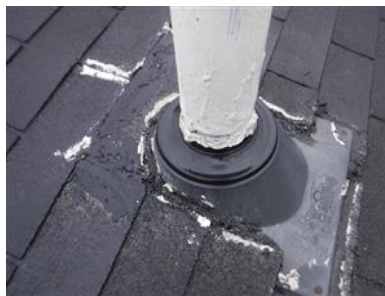
Several roof penetration(s) have been caulked/sealed around perimeter. Water intrusion into the home can lead to costly repairs and/or undesirable living conditions. Recommend monitoring for signs of leaking or deteriorating of the sealed area and repair/replace as needed.

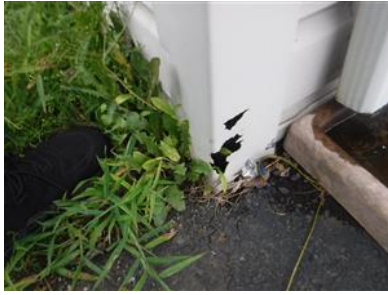
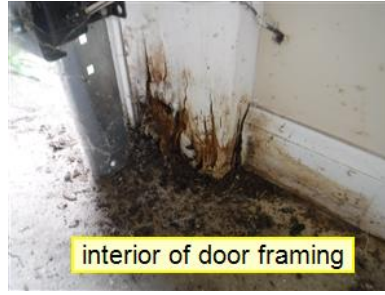
The wood trim at the basement exterior entry door shows signs of damage from what appears to be wood destroying insects. Repairs are needed and concealed damage may be present. Recommend a qualified contractor and pest control company evaluate further and complete all needed repairs.

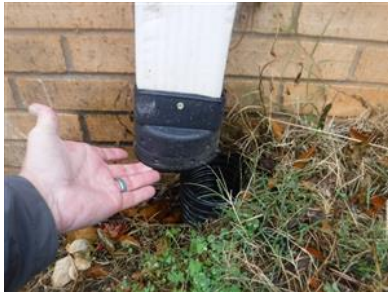
2.3 Item 1 (Picture)

Ground drain-line has settled and pulled loose from downspout on front left corner of home. Water draining next to the foundation will cause water enter into the foundation. Reconnect for proper drainage.

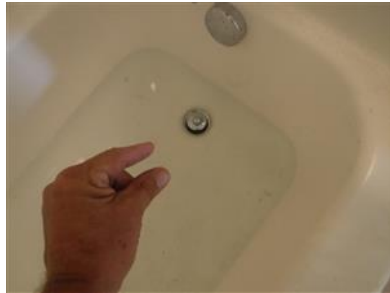
10.5 Item 1 (Picture)

The plumbing waste line drains slowly at the hall bath. The reason or cause is unknown. This item is not functioning as intended and needs repair. A qualified professional should evaluate further and advise.

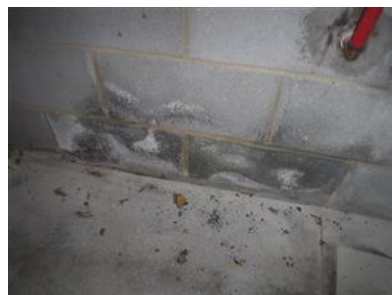
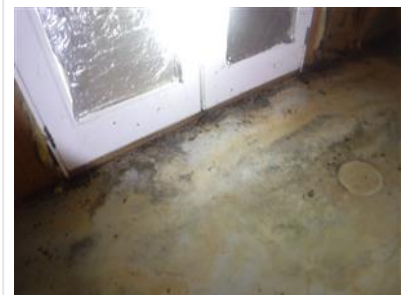
Visible signs of water intrusion in the basement are present from dampness. Water intrusion can lead to more costly repairs and increase damage if not corrected.. I recommend further investigation or correction by a qualified licensed contractor or water infiltration specialist.

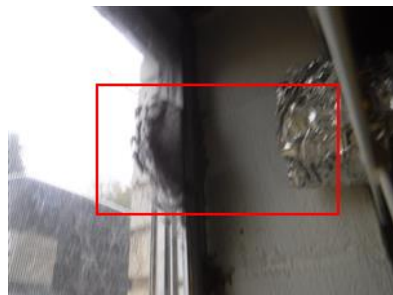
14.5 Item 1 (Picture)

The dryer vent pipe is disconnected in the basement. Over time the additional moisture these devices add to the crawlspace can cause damage. The lint produced by the dryer is also highly flammable. Recommend repair as needed.

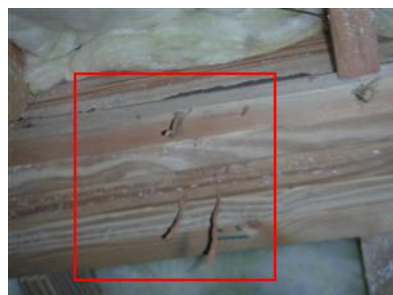
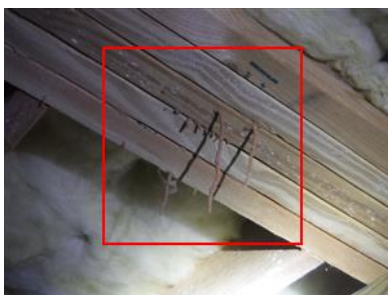
Evidence of wood destroying insects observed in the floor structure in basement. Repairs are needed and concealed damage may be present. Recommend consulting a licensed pest inspector and a qualified contractor for further evaluation and repair.

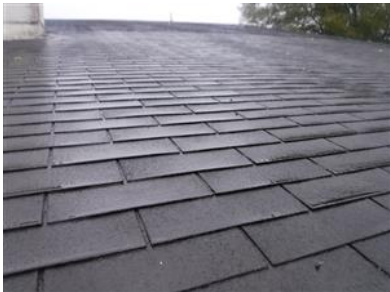
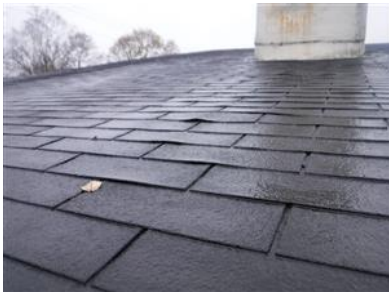
The roof shingles are curled and brittle and are pitted in areas. Areas have also been heavily caulked or sealed. The life remaining is unknown. Recommend further evaluation by a licensed roofing contractor.

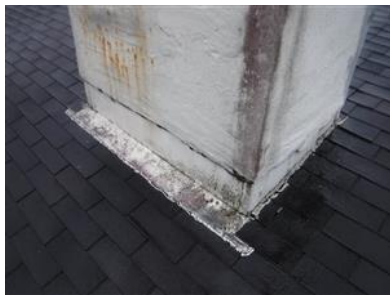
1.1 Item 1 (Picture)

Flashing around chimney has been caulked. This area may leak (or could be leaking). Water intrusion into the home can lead to costly repairs and/or undesirable living conditions. Recommend monitoring for leaks and repair as needed by qualified contractor. Periodic inspection/maintenance of any caulked flashing is also recommended.

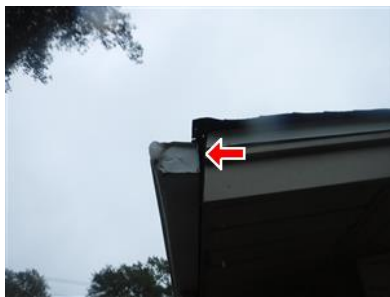
1.2 Item 1 (Picture)

(1) The gutter along the right side of home has pulled away from the fascia board and is not operating properly. Water intrusion in through the foundation may occur if not corrected (or is occurring). Water infiltrating the home may cause damage to the structure and/or cause fungal growth. Repairs are needed. Recommend a qualified professional evaluate further and repair.

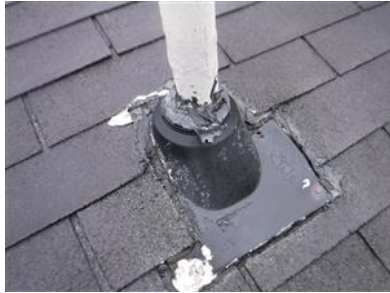
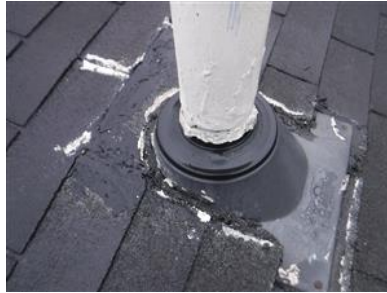
Several roof penetration(s) have been caulked/sealed around perimeter. Water intrusion into the home can lead to costly repairs and/or undesirable living conditions. Recommend monitoring for signs of leaking or deteriorating of the sealed area and repair/replace as needed.

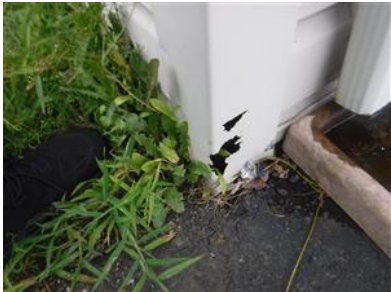
2.0 Item 1 (Picture)

The wood trim at the basement exterior entry door shows signs of damage from what appears to be wood destroying insects. Repairs are needed and concealed damage may be present. Recommend a qualified contractor and pest control company evaluate further and complete all needed repairs.

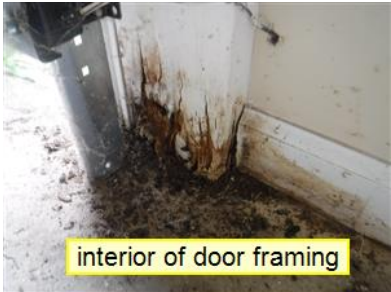
2.0 Item 2 (Picture)

interior of door framing

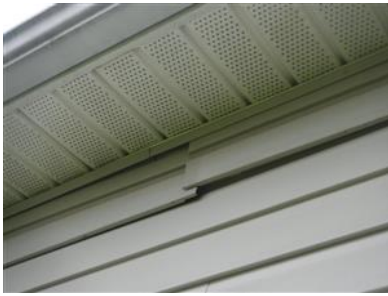
2.1 Item 1 (Picture)

Areas of the vinyl siding are not secure along the rear of home. Recommend repair as needed to prevent wind damage.

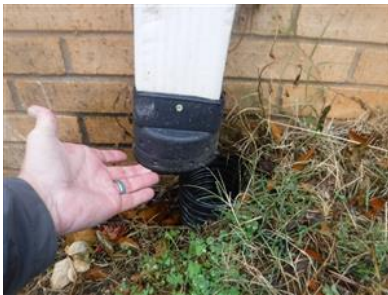
2.3 Item 1 (Picture)

Ground drain-line has settled and pulled loose from downspout on front left corner of home. Water draining next to the foundation will cause water enter into the foundation. Reconnect for proper drainage.

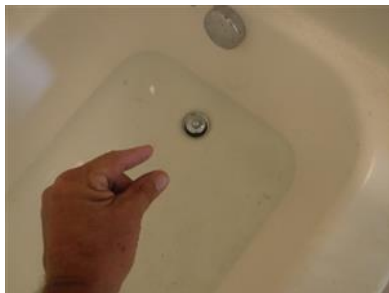
10.5 Item 1 (Picture)

The plumbing waste line drains slowly at the hall bath. The reason or cause is unknown. This item is not functioning as intended and needs repair. A qualified professional should evaluate further and advise.

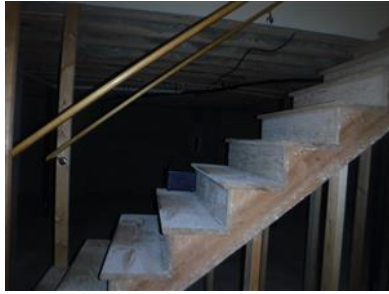
11.3 Item 1 (Picture)

The balusters for the stairs to basement are not present. An injury could occur if not corrected. Install as needed.

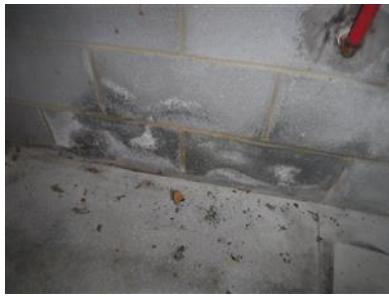
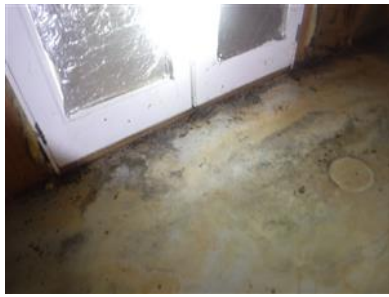
Visible signs of water intrusion in the basement are present from dampness. Water intrusion can lead to more costly repairs and increase damage if not corrected.. I recommend further investigation or correction

by a qualified licensed contractor or water infiltration specialist.

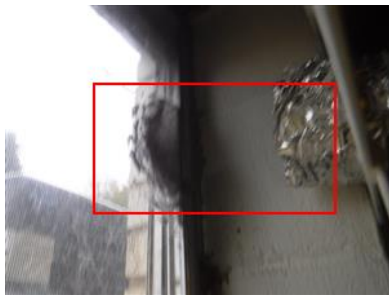
14.5 Item 1 (Picture)

The dryer vent pipe is disconnected in the basement. Over time the additional moisture these devices add to the crawlspace can cause damage. The lint produced by the dryer is also highly flammable. Recommend repair as needed.

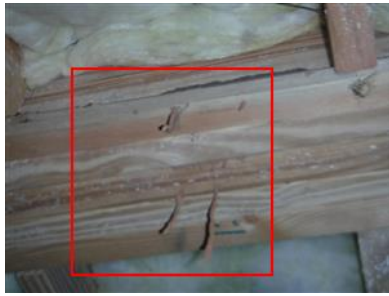
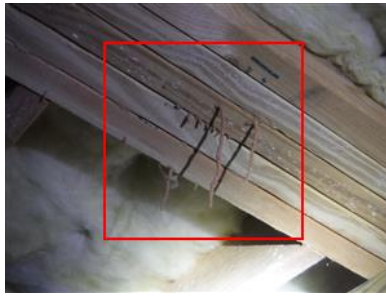
Evidence of wood destroying insects observed in the floor structure in basement. Repairs are needed and concealed damage may be present. Recommend consulting a licensed pest inspector and a qualified contractor for further evaluation and repair.
